## DAM BREAK DURING THE FLOOD IN SAXONY/GERMANY IN AUGUST 2002

A. BORNSCHEIN, R. POHL

Dresden University of Technology, Germany

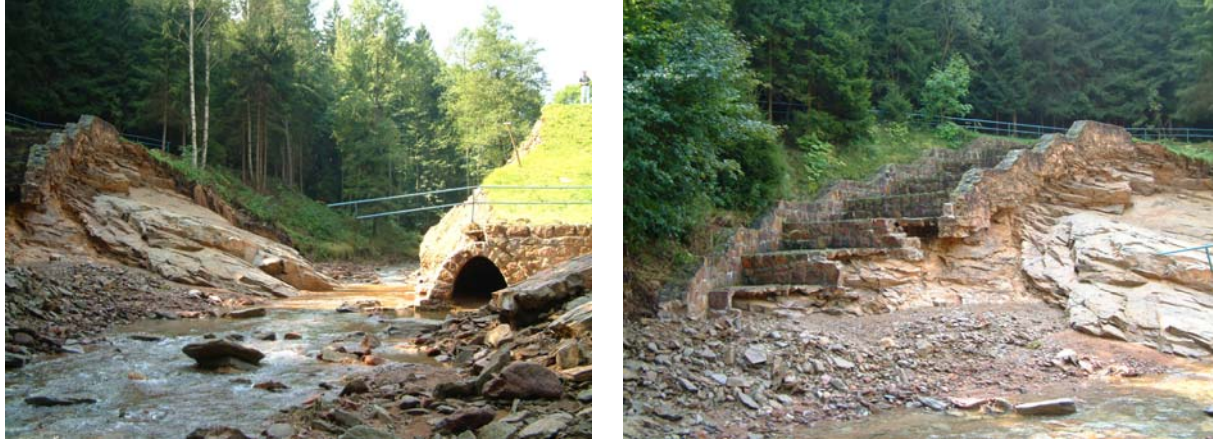
The barrage is an earthfill embankment dam with a straight dam axis and a height of about 9 m. The dam crest level is about 388.7 a.s.l. The upstream and downstream face is sloped 1 on 2 and covered with grass. After the breach it is now obviously that there are stones within the earth material of the dam, especially in the upper part of the dam. There is no sealing in the upstream dam face and no drainage in the downstream dam toe.

Figure 1: Broken section (left) and stepped spillway (right) after rupture.

There is a stepped spillway with 7 steps each 1m high. It had a capacity of about  $5 \text{ m}^3/\text{s}$  just when the water level reached dam crest (Figure 1). The river Briesnitz passed the dam through outlet tunnel with natural stoned masonry. Cross section of the outlet is about  $1.7 \text{ m}^2$ . The discharge through the outlet is reduced to  $7 \text{ m}^3/\text{s}$  in order to protect the downstream town.

The main reason for the Glashütte dam break was the insufficient dimensioning of the spillway and the freeboard. The situation was made worse by congesting the bottom outlet by brush-wood, trees and rubbish.

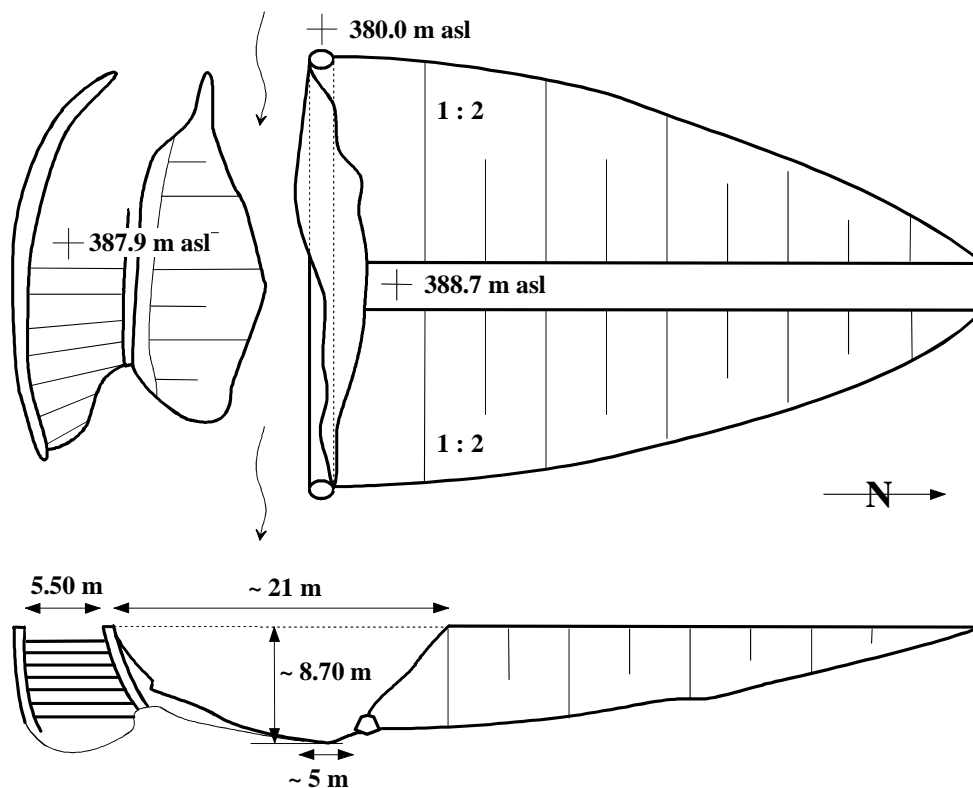
Figure 2: Glashütte embankment dam in plan (top) and downstream elevation (bottom).

Figure 1 shows two photos of the final dam breach and in Figure 2 a sketch of the final breach of Glashütte embankment dam measured on 23. August 2002 is given.

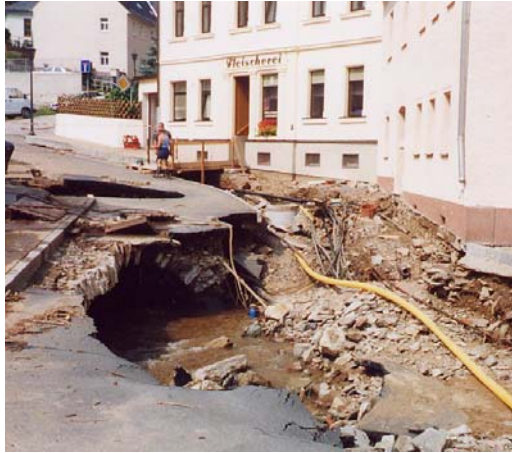
As the break happened on 12. August between 4.10 and 4.40 p m its peak did not coincide with the peak caused by the rain in the Müglitz River. The graphs in Figure 8 show that the peak due to the dam break did not exceed the later passing peak of the Müglitz River. Therefore the additional damages due to the break remained limited to the direct downstream reach (Figure 9).

Figure 9: Damages caused by the dam break wave in town of Glashütte.
